Details of the SLT reparation problem

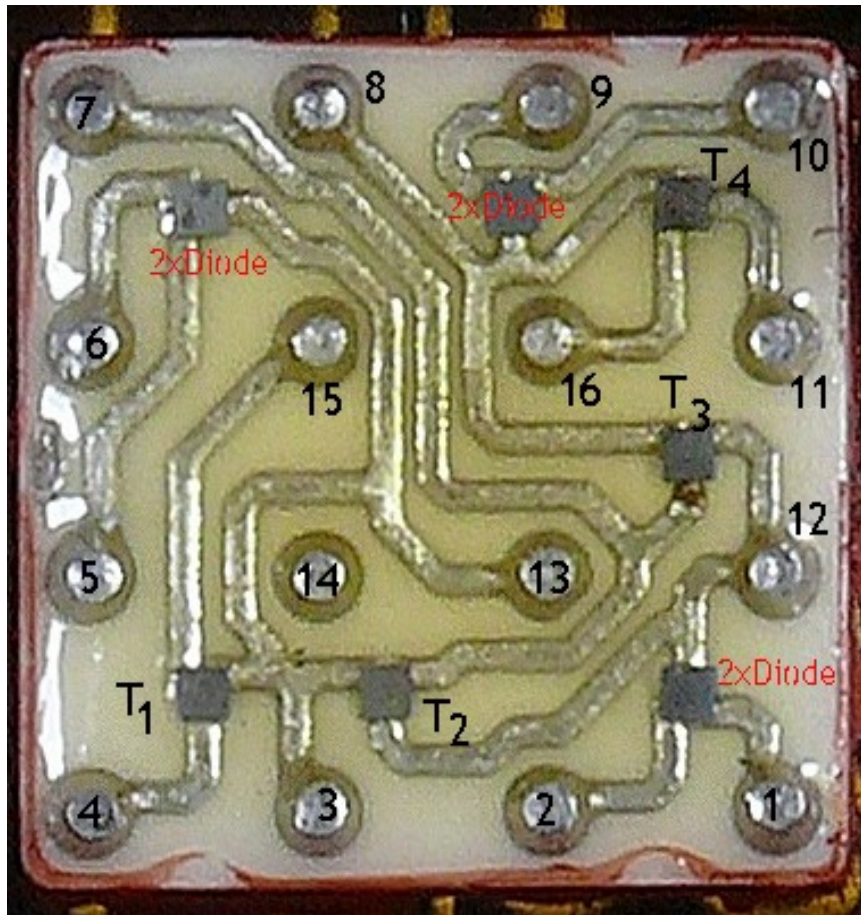
To the left: SLT latch

The SLT card (right hand picture) shows, among other parts, the 16 latches used for caching the printer data. The latch labeled no. 6 is defect.

After removing the SLT case, one can see the discrete transistor and diode units with a magnifier. The resistances at the back of the ceramic-makers are not accessible. Now we can replace faulty transistors by standard transistors on the back of the SLT card.
